## Heat resistant alloys: Selection and failure avoidance

*Jason Wilson, Devin Wachowiak (Rolled Alloys USA), Stephen Pollard (Rolled Alloys UK), and Alex Huang (Rolled Alloys China)*

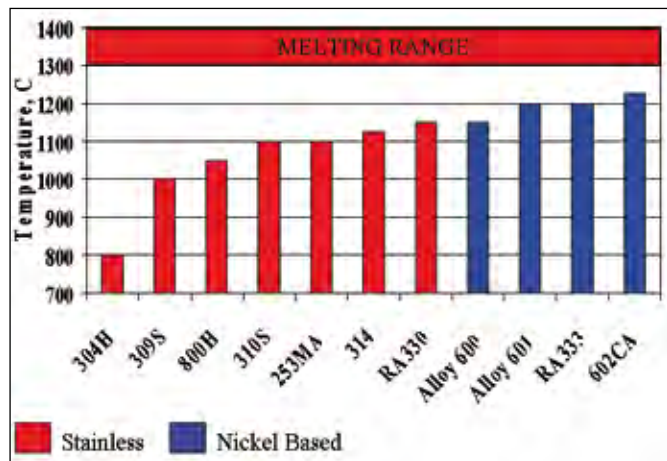
Suggested temperature limits in air for various heat resistant alloys. Red Colors are stainless steels and blue colors are for nickel-based alloys.

The first two criteria for materials selection should be what is the maximum operating temperature of the alloy and then does it possess the necessary strength for the application. Alloy suppliers like Rolled Alloys list the suggested maximum operating temperature for each alloy in their literature. This temperature is typically based upon when the rate of scaling from oxidation becomes unacceptable. It is *not* based on melting temperature. Most heat resistant alloys have

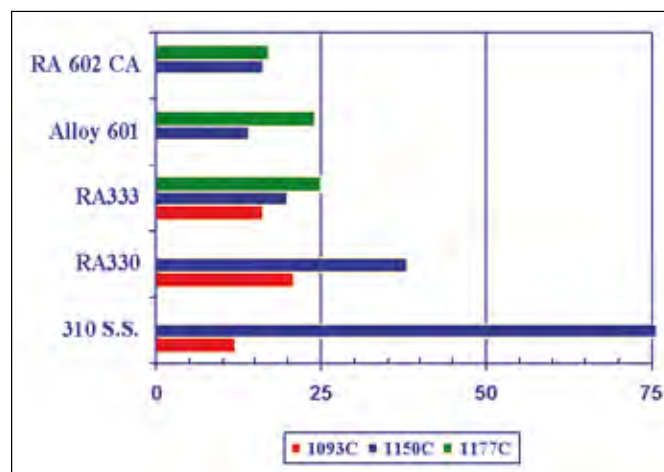
Weight gain (mg/cm<sup>2</sup>) during cyclic oxidation testing. Samples cycled weekly to room temperature. Total test time 3000 hours.

It is important to understand that the actual temperature of a muffle or calciner is normally hotter than the temperature of the exiting parts or powders. When the economy is good it is not unusual to demand greater production rates through a furnace. This means the operating conditions for the alloy muffle, calciner, etc. have changed. The production parts are seeing the same temperatures, however, to heat up the additional mass in the same time period more heat must be put into the furnace through the muffle or calciner wall. Although the process appears to be the same, the muffle or radiant tube is seeing tougher conditions and this often means decreased life. Small increases in temperature dramatically impact the properties of high temperature alloys. It is interesting to look at what an extra 100°F (56°C) in metal temperature can do to material performance. From a scaling standpoint if you go beyond the temperature capability of the alloy they can scale at significantly faster rates. An example of scaling rates of various alloys is shown. Note that 310 stainless is rated to 2000°F (1093°C). At that temperature it has relatively low weight gain, however at 2100°F its oxidation rate is off of the chart.

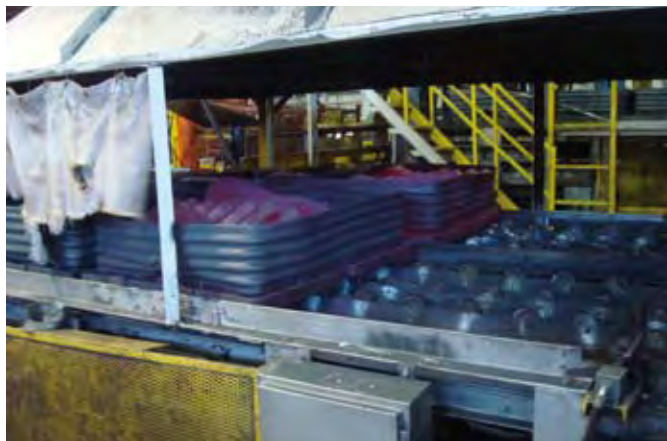
253MA corrugated boxes fabricated from 3mm sheet (11ga) replaced 309 and RA330 in this isothermal heat treating operation at 1750°F (954°F). The higher strength has extended fixture life over both materials.

Taking advantage of high strength alloys can lead to cost savings even if their cost per kilogram may be more. 253MA alloy is only 11% nickel yet it provides greater strength than 35% nickel, RA330 along with higher strength. In many applications operating below 2000°F (1093°C) this alloy is being considered to replace 309, 310, and some nickel alloys.

Photos in this article show two operations where 253MA has successfully been substituted in place of 309, 310, and RA330.

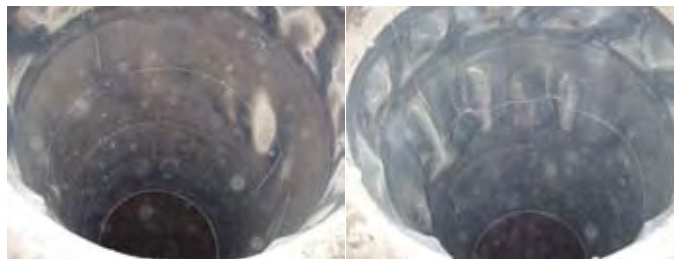
253MA replaced type 310 stainless in this fluidized bed cyclone dip tube. That measures 8.5 ft (2.6 m) diameter and 23 feet (7 m) long and operates at 1600°F (871°C). 253MA lasts at least 6 years before distortion shown at right led to its replacement. 310 stainless required replacement every 2-3 years.

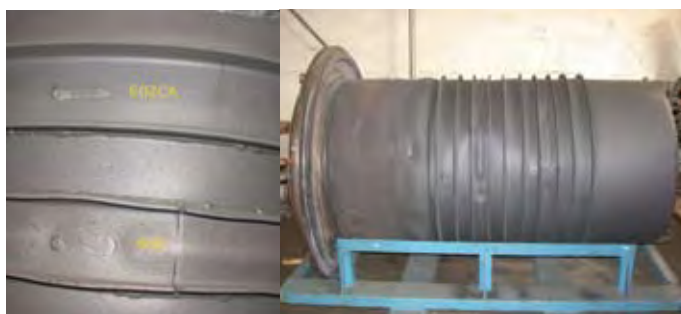
Top overall of a coating retort made of 600 alloy with alternating reinforcement ribs of alloy 600 and 602CA. The higher strength of 602CA is evident in the close up view as is its better oxidation resistance. The 600 channel and retort wall have a roughened surface due to oxidation. The process inside the retort operates at 1975°F (1080°C).<sup>5</sup>

The figures below show the original design of a retort used in a furnace to apply aluminum rich coatings to gas turbine engine blades. The low strength of alloy 600 at 1975°F (1080°C) led to the addition of significant external reinforcement to combat distortion of the 3/8 inch (9.5 mm) sidewall. The higher strength of 602 CA allowed the elimination the external reinforcements completely. The simplified design was 35% lighter weight than the more complex alloy 600 fabrications. The simple 602CA design has a lower initial cost and has been lasting on average between 2-3 times as many cycles as the complex alloy 600 design. Other benefits are the furnace load sees more even heat distribution allowing better process control, less energy is wasted heating up the retort, and the excellent oxidation resistance of 602CA has reduced part rejection due to scale contaminating the finished parts.

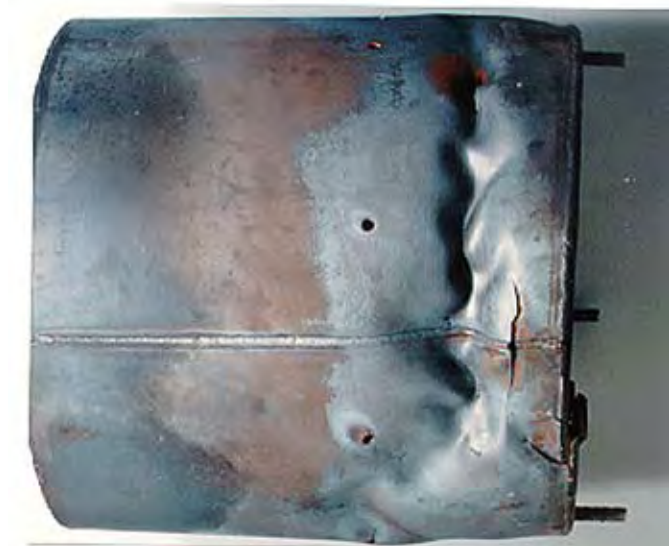
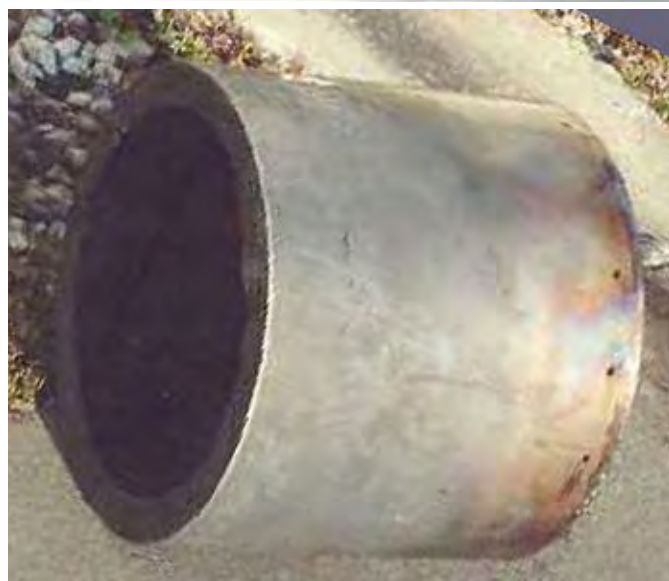
This burner can made of 3mm (11ga) 253MA is a good example of what can happen when uneven heating occurs. In this case above, flame impingement occurred during a low fire condition. The photo below shows a can after use with a good temperature profile under normal operating conditions. Gas flow is right to left.

The burner can shown in Figure 8 shows what can occur with uneven heating. During low fire the burner flame impinged on the walls of the burner can. The shiny glazed scale where the can has distorted indicates high heat exposure. The other areas of the burner can operated at much lower temperatures. The area with flame impingement was restrained from expanding by the cooler areas of the can. These cooler areas are also stronger because of their lower temperature. As a result, the area of flame impingement collapsed.

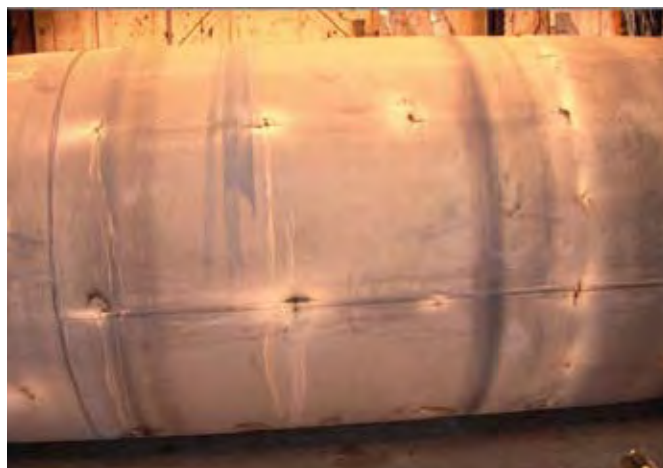
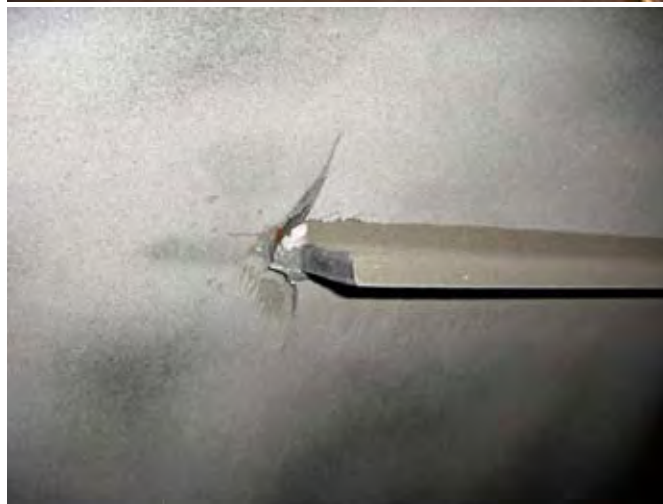
Calciner shell fabricated from 3/8 inch (9.5 mm) plate that suffered cracking. This was a result of temperature differentials between the shell and internal flights.

A calciner shell suffered cracking that occurred in a definite pattern (see photo). These cracks were found to occur at the ends of each internal flight (see photo). The cause of this cracking was temperature differentials between the shell and the flights. Gas-fired burners externally heated the calciner. The flights on the other hand were heated by energy conducted through the shell and were cooled by their more direct contact with the powders being processed. As a result, the flights operated at a lower temperature than the shell. As the hotter weaker shell tried to expand the cooler stronger flights restrained it. This resulted in the shell cracking under the stress at the ends of the flights. In this case, the suggestion was to refrain from solidly welding the flights. Instead weld the flights to the shell only at the center, leaving the ends free to expand or contract free of the shell.
