RA333® Flare Tip Completes its 3½ Year Tour of Duty and is Readied for a Second

Case History

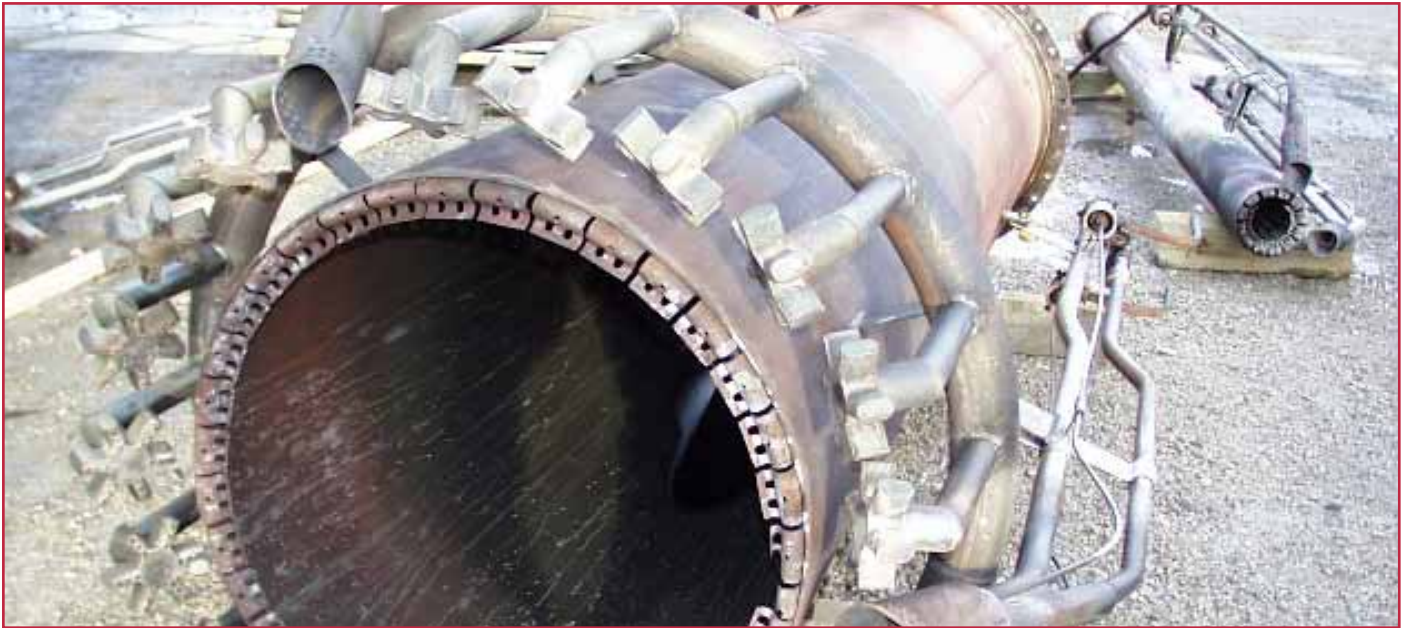
The second RA333 tip, installed October 1995 was taken down during a shutdown in March 1999. After 3½ years service, the RA333 portion was like new. The only items requiring repair were those portions still made of 310 or HK castings such as steam nozzles and the pilot flares. The flare will be kept on hand as a spare and will be installed during the next scheduled shutdown.

The flare tips here consist of a 66 inch long cylinder of 3/8 inch thick RA333 plate at the top, (1676 mm long, 9.5 mm plate) butt welded to a like cylinder of carbon steel. The stack itself is a 30 inch diameter pipe, 237 feet tall from base to top (762 mm diameter, 72 m tall). Maximum capacity is 640,000 pounds per hour of waste gas. To get a "Smokeless Flame" steam injection is used to increase combustion of the hydrocarbons. Flare tips are subjected to flame impingement on the outside, low flow conditions, and/or internal burning. Strong winds can blow the flame onto the flame retention rings, and on the outside. If the old refractory lining failed, air infiltration could cause internal burning to the point where the tip was seen to glow red.
